## ANALYSIS OF SOIL-NAILED EXCAVATIONS STABILITY DURING THE 1989 LOMA PRIETA EARTHQUAKE

By Mladen Vucetic, University of California, Los Angeles;  
Mark R. Tufenkjian, California State University, Los Angeles;  
Guy Y. Felio, National Research Council, Ottawa, Canada;  
Pirooz Barar, Pirooz Barar & Associates, Oakland, California; and  
K. Ronald Chapman, Schnabel Foundation Co., Walnut Creek, Calif.

### ABSTRACT

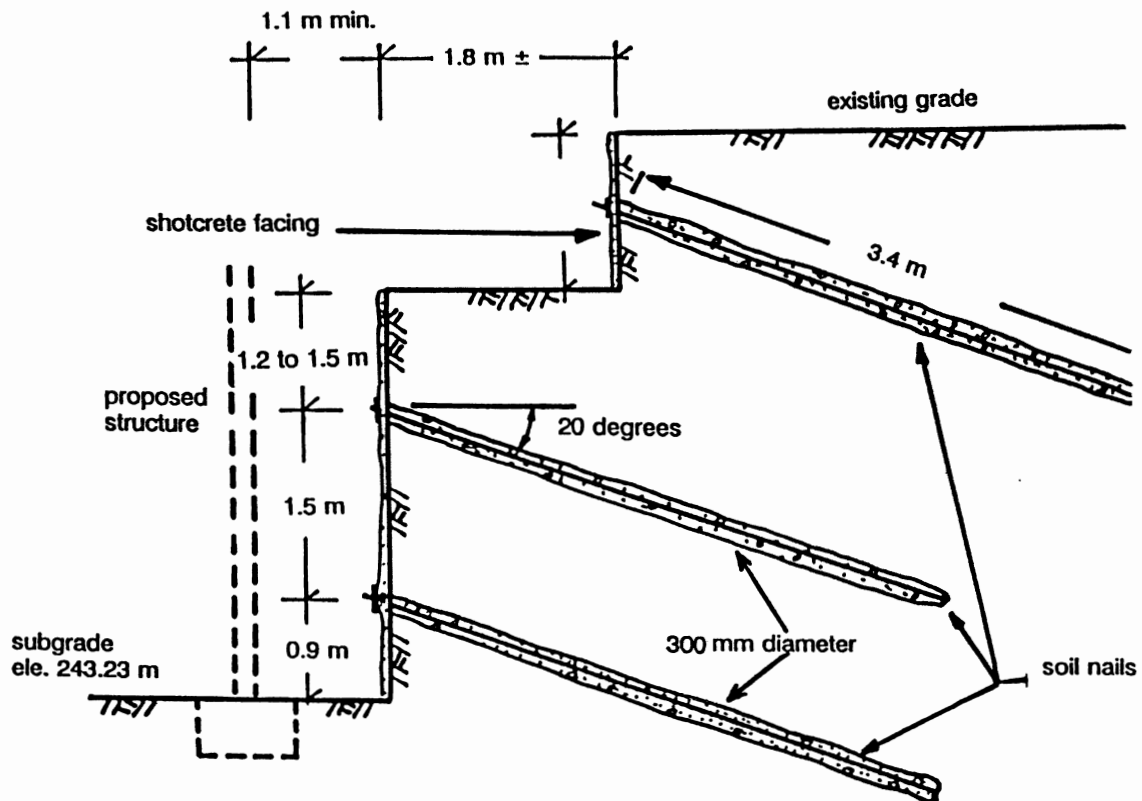
Figure 2.—Cross section of a soil-nailed excavation for a building constructed in Santa Cruz (UCSC wall), Calif. (Felio and others, 1990).

Approximately 350 m<sup>2</sup> of shoring was required to construct a new science library on the UCSC campus. The soil conditions at the site consisted of sandy silt to sandy clayey silt extending from the ground surface to a depth of approximately 6.4 m. The soil has an average dry unit weight of 13.8 kN/m<sup>3</sup> and a moisture content ranging from 26.2 percent in the clayey silt near the surface to 13.9 percent in the sandy silt at 6.4 m. Shear strength properties used in design were  $c = 23.9$  kN/m<sup>2</sup> and  $f = 25^\circ$ . The cross section at the highest location of the wall is shown in figure 2. Construction of the wall was completed on September 28, 1989, less than 3 weeks before the earthquake. Since three sides of the excavation were soil nailed, at least one side may have been subjected to the full strength of the earthquake, which pro-

duced in the vicinity of the excavation peak horizontal ground-surface accelerations of about 0.47 *g*. It should be noted that this wall was located closest to the epicenter and presumably was subjected to the strongest shaking, while at the same time it had the smallest length ratio and thinnest facing among the nine walls examined (see tables 1 and 2). Prior to the earthquake, some wall and column spread footings had been poured (see fig. 2). A postearthquake inspection revealed significant cracking in the concrete of the footings. This cracking was not attributed to shrinkage since foundations constructed after October 17 showed fewer cracks. As opposed to that, the inspection of the soil-nailed wall after the earthquake revealed no cracking. A week after the earthquake, nine nails were tested to 150 percent of their design pull-out load. The tests showed no loss in the carrying capacity of the nails due to the seismic activity.

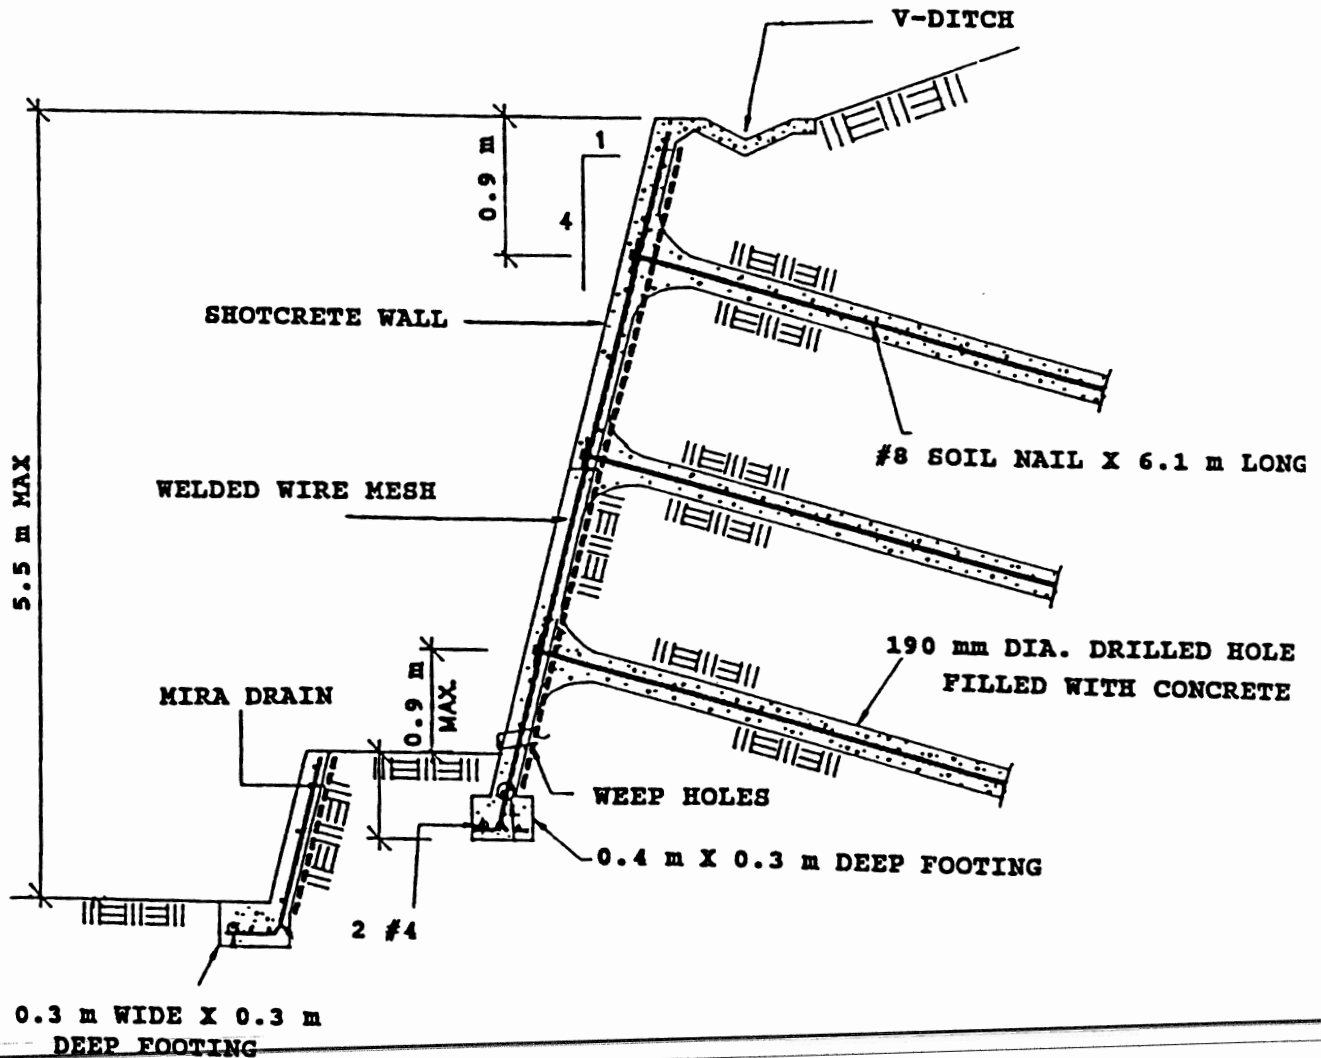
Figure 3.—Cross section of a permanent soil-nailed retaining structure located in San Ramon (NME wall), Calif. (Barar, 1990).

This soil-nailed retaining structure forms a part of a permanent retaining wall used for the roads and landscape that surround the medical center. The wall cross section is shown in figure 3. According to the geotechnical report, the soil conditions consist mainly of engineered fill up to a maximum depth of 24 m, generated from cut-and-fill operations performed previously. Therefore, the soil-nailed retaining structure was built in fill material. The fill consists of sandy and silty clay of moderate to high plasticity, with an average dry unit weight and moisture content of approximately 17.1 kN/m<sup>3</sup> and 18 percent, respectively. The shear strength prop-

erties used in design were  $c = 47.9$  kN/m<sup>2</sup> and  $f = 0^\circ$ . Since this is a permanent structure, the facing of the soil-nailed wall was finished with a colored architectural concrete finish. The postearthquake walk-through revealed that the surface of the concrete remained smooth and free of cracks.

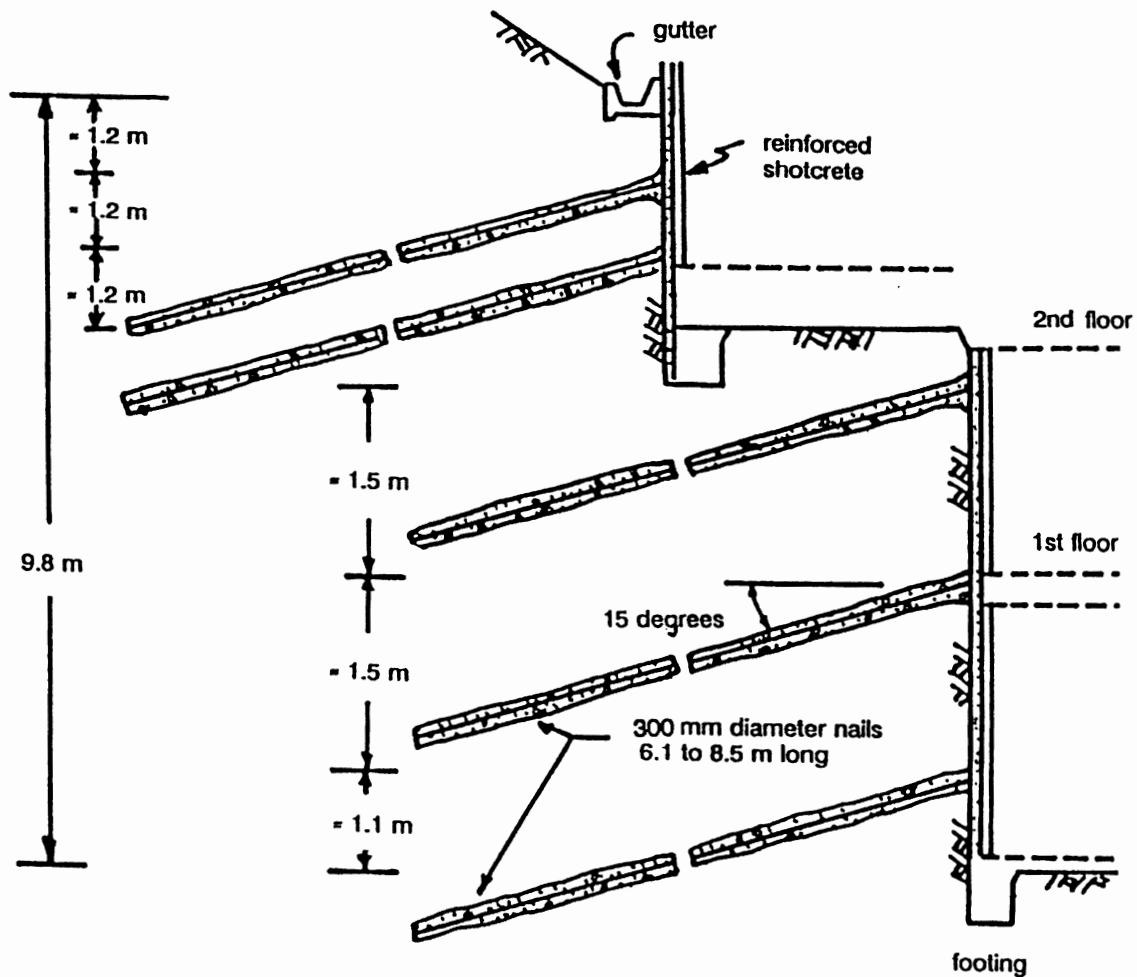
Figure 4.—Cross section of a soil-nailed retaining wall constructed on a steep hill in San Francisco (CVA wall), Calif., to provide adequate space for an apartment complex (Felio and others, 1990).

steep hill to make room for the development of a housing project. The wall cross section is shown in figure 4. The 9.8-m-high soil-nailed structure was constructed at the toe of a 45.7-m-high slope to allow for the construction of apartment units. The wall is about 90 m long and consists of two levels. Due to the permanent nature of the structure, a 200 mm reinforced concrete facing and a small footing at the base were used. The soil conditions at the site can be described as colluvium and residual soil deposits. The design parameters used were cohesion  $c = 9.6 \text{ kN/m}^2$  and an angle of internal friction of  $f = 35^\circ$ . The inspection that took place 3 days after the earthquake showed no signs of distress to the wall and no indications of lateral movements or tension cracks in the hill behind the wall.

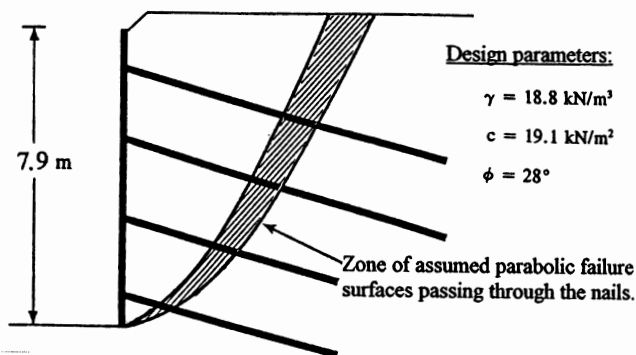
Figure 10.—Assumed failure surfaces passing through the nails for the factor of safety evaluation of the TSW wall in Richmond using Davis method and its modifications.

sented in table 4. The location of the assumed failure surfaces that yield minimum factors of safety for the TSW wall are shown in figure 10. In general, the factors of safety are relatively low, especially for the range of estimated peak horizontal ground accelerations during the Loma Prieta earthquake. According to such low factors of safety, and given the fact that some soil-nailed structures were probably subjected to much larger horizontal forces, some visible damage should have occurred during the earthquake. This should have been expected in particular for the UCSC Wall in Santa Cruz, which had the smallest length ratio and facing thickness, and yet is likely to have undergone horizontal seismic forces as large as 0.4 g. The lack of visible damage on any of the walls, except very thin cracks on the ECR wall, suggests that either the design, analysis, or construction, or most likely their combination, may have been more conservative than necessary. The lack of damage also indicates that the assumed failure surface and mechanism of failure of the Davis method may not be fully appropriate for the nine walls treated here. In the following section, the components of the analysis, design, and construction that appear to be on the conservative side, and therefore could be responsible for such excellent seismic performance, are discussed.

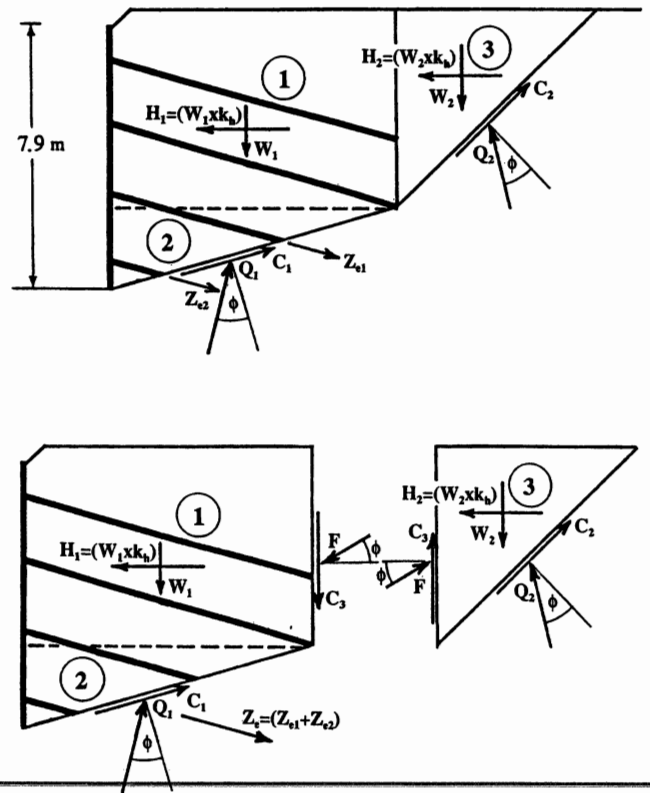
Figure 13.—Failure surfaces and forces for the TSW wall employed in both SKGG and CALTRANS methods for the calculation of the factor of safety according to the German type of failure.

To examine the factors governing the failure corresponding to the above mechanism, the forces and factors of safety for the TSW Wall in Richmond (see fig. 10 and table 4) are reevaluated. Figure 13 shows the assumed failure surfaces and governing forces, while figure 14 shows the corresponding polygons of forces. To account for the effects of dynamic horizontal forces the pseudostatic method of analysis is used again, where the dynamic action is represented by the static horizontal force  $H = W \times k_h$ . Two definitions of the factor of safety,  $FS$ , based on the German

To confirm the above conclusions, the factors of safety of the eight soil-nailed walls subjected to the Loma Prieta earthquake were calculated by the Caltrans method. The four-level RPP wall located in San Jose could not be accurately reproduced using the SNAIL program. The wall geometries were scaled from figure 8 and the soil design parameters were taken from table 1. The calculated factors of safety are shown in table 5, where those corresponding to the range of estimated horizontal ground-surface accelerations near each soil-nailed wall are indicated by double-headed arrows. Note that the factors of safety are generally much greater than unity for the range of estimated ground-surface accelerations, even for the UCSC wall which was subjected to horizontal accelerations in the range of 0.4 to 0.5 g. Recall from Table 4, for example, that the Davis method predicted failure ( $FS = 1.0$ ) for the TSW wall for the acceleration coefficient between

0.10 and 0.20, while the Caltrans method required an acceleration coefficient between 0.4 and 0.5. Such large values of *FS* obtained by Caltrans method are in agreement with the excellent performance of the walls during the earthquake.

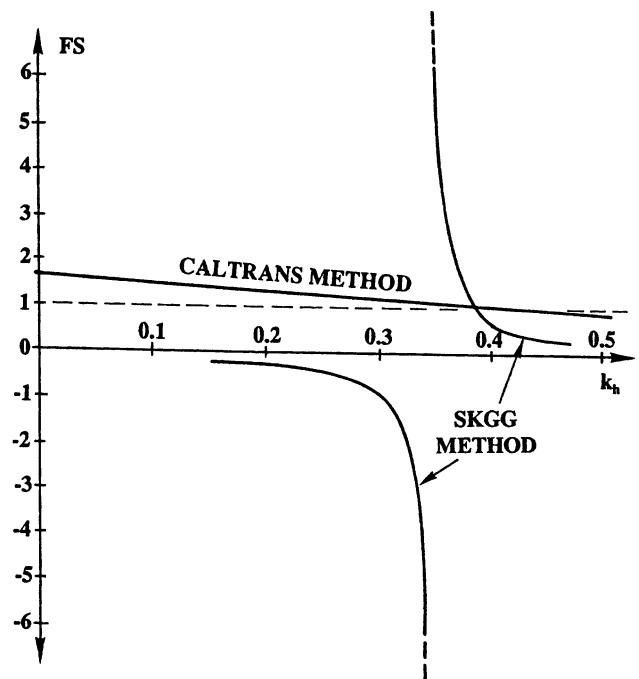
Figure 15.—Variation of the factors of safety, *FS*, with the seismic coefficient,  $k_h$ , for the TSW wall.

Several interesting conclusions can be derived from figure 15. First is that for  $FS = 1$  (the conditions of the failure of the wall),  $k_h \approx 0.37$  is obtained by both methods. Second, this  $k_h$  value is much larger than  $k_h \approx 0.1$  to  $0.20$  corresponding to  $FS = 1$  calculated according to the Davis method (see table 4). Third,  $k_h \approx 0.37$  is in relatively good agreement with the amplitude of the cyclic acceleration of  $0.45 g$  that was required in the centrifuge testing for the failure of the soil-nailed excavation model of similar length ratio (see Vucetic and others, 1993). And fourth, the  $FS$  versus  $k_h$  relationship for the SKGG method has a singularity point, while the same relationship for the Caltrans method does not.

Based on these observations it can be concluded that the failure mechanism according to the German method seems to be more appropriate than that of the Davis method. However, figure 15 also shows that using the SKGG method to calculate the factor of safety may not be suitable for the calculation of stability involving the horizontal forces ( $W \times k_h$ ), because it is too sensitive to the variation of  $k_h$ . By varying  $k_h$  from  $0.3$  to  $0.4$ ,  $FS$  varies from  $-1$  to  $-\infty$  and then from  $+\infty$  to  $0.7$ —that is, as noted above, the function  $FS = f(k_h)$  has a singularity point. The reason for such sensitivity of  $FS$  with respect to  $k_h$  can be easily understood from the polygon of forces in figure 14B. For example, if the force  $H_1 = W_1 \times k_h$  is increased by only 15 percent, the  $Z_c$  force will double—that is, change by 100 percent. Consequently, the  $FS = Z_o/Z_c$  will change dramatically too. Such sensitivity of  $FS$  comes from the fact that  $FS$  is defined on the basis of forces which are of secondary importance for the stability of the structure. In other words, force  $Z_c$  is relatively small compared to the other forces in the polygon. More dominant forces are apparently the reaction force  $Q_1$  and cohesion force  $C_1$  mobilized along the failure surface.
