## ANALYSIS OF SOIL-NAILED EXCAVATIONS STABILITY DURING THE 1989 LOMA PRIETA EARTHQUAKE

By Mladen Vucetic, University of California, Los Angeles;  
Mark R. Tufenkjian, California State University, Los Angeles;  
Guy Y. Felio, National Research Council, Ottawa, Canada;  
Pirooz Barar, Pirooz Barar & Associates, Oakland, California; and  
K. Ronald Chapman, Schnabel Foundation Co., Walnut Creek, Calif.

### ABSTRACT

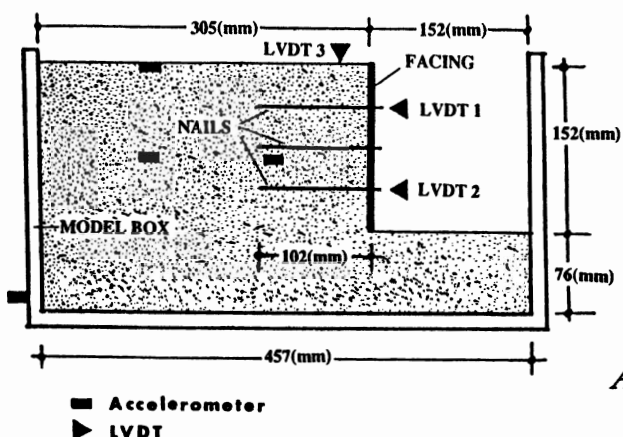
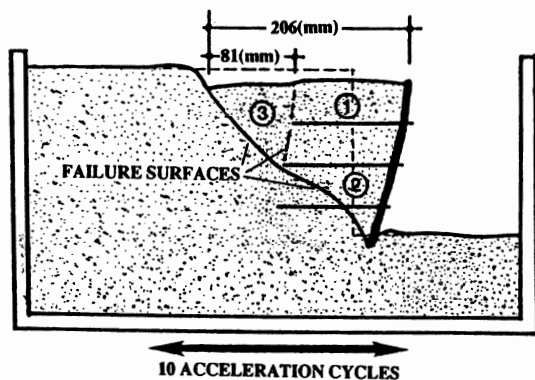
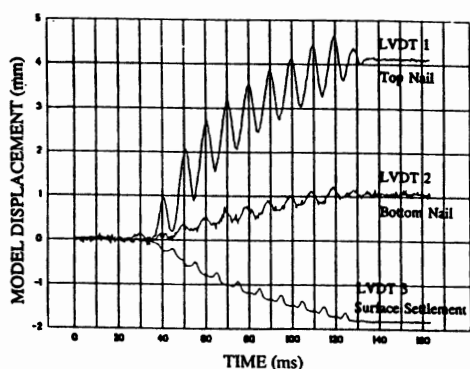
Figure 11.—Features of the typical centrifuge model test with length ratio of 0.67 (Tufenkjian and others, 1991; Vucetic and others, 1993). A, Longitudinal cross section of the soil-nailed excavation centrifuge model box. B, Failure mechanism obtained in the centrifuge due to strong horizontal shaking. C, Typical records of soil mass movements during shaking with 10 cycles of  $0.27 g$  cyclic acceleration amplitude.

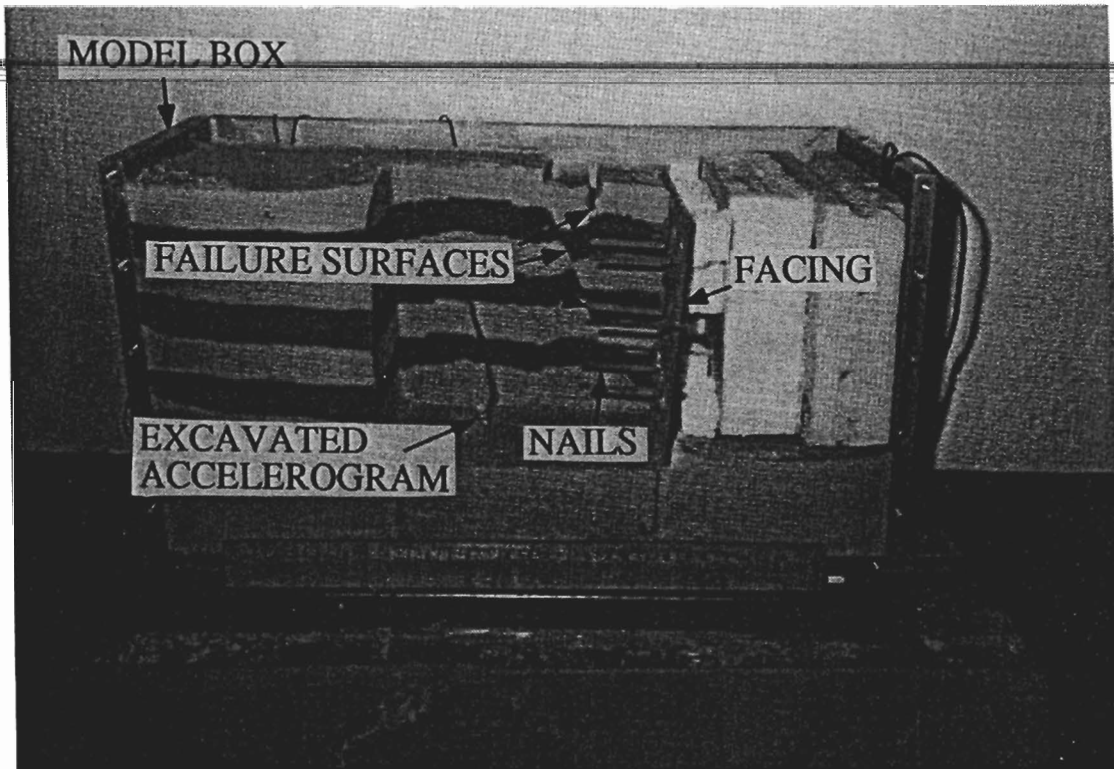
Figure 12.—Excavated model of a test with the length ratio of 0.33 (short nails) shaken by 10 cycles of the uniform acceleration amplitude of 0.10 g.
