29th ANNUAL CONFERENCE
ON DEEP FOUNDATIONS

PERMANENT SOIL NAIL EARTH RETENTION SYSTEM, STANLEY HALL REPLACEMENT PROJECT, UC BERKELEY

To mitigate the lateral earth pressures, a permanent Soil Nailed Wall, integrated with the structural system of the building was designed. PB&A, Inc.'s in-house design program "Winslope" was utilized to design the system and the data obtained from a rigorous monitoring program, were used to calibrate several computer runs using Plaxis program.

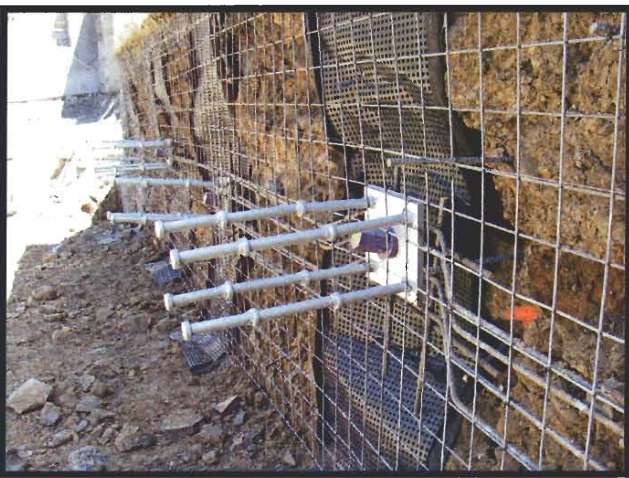
Fig. 9: Nelson Stud

In the case of Stanley Hall, because of the very high water table, drainage and water proofing were of predominant importance. Also, the fact that the structural wall and the Soil Nail wall were to be integrated by “stitching” them together through the use of Nelson Studs (see Fig. 9), the design called for the shear plates to be recessed into the exposed face of the excavation (see Fig. 10), allowing only the Nelson Studs to protrude through the water proofing surface.

Corrosion protection was achieved by encapsulating double corrosion-protected Soil Nails (DCP) in polyethylene corrugated sheathing. The tips of the Soil Nails, as well as shear plates and miscellaneous attachments, including the Nelson Studs, were epoxy coated. See Fig's. 9 and 12.

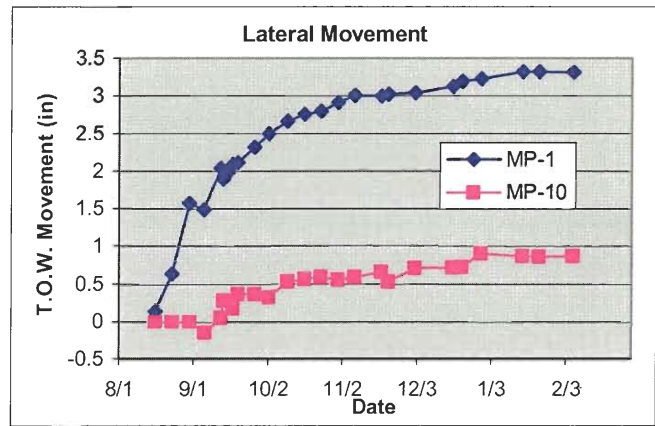
Fig. 11: Horizontal Movement – MP-1 & MP10

Monitoring stations MP-1 and MP-10 are located at northeast and southeast along the east wall. Although these walls have similar heights, they exhibited different amounts of movement. Station MP-10, which is close to the location where analysis model was presented, had less than 1 inch of movement as shown in figure 7. Generally, locations near corners are fairly stable and do not show excessive movements, but due to the height of excavation and geology of the site, the northeast corner of this site showed a few inches of lateral movement; see figure 9.

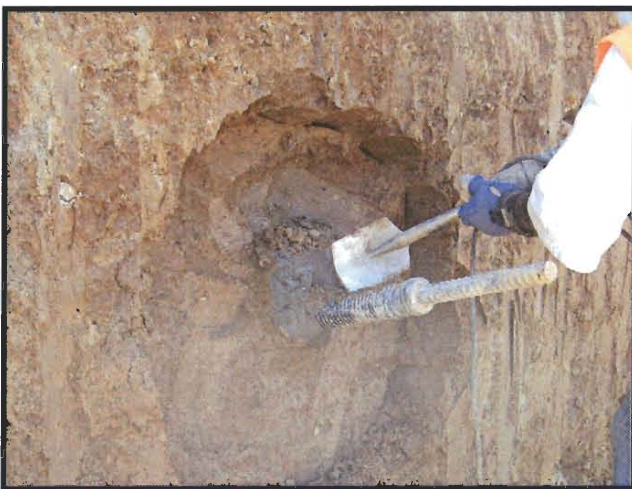
Fig. 10: Recessed Shear Plate

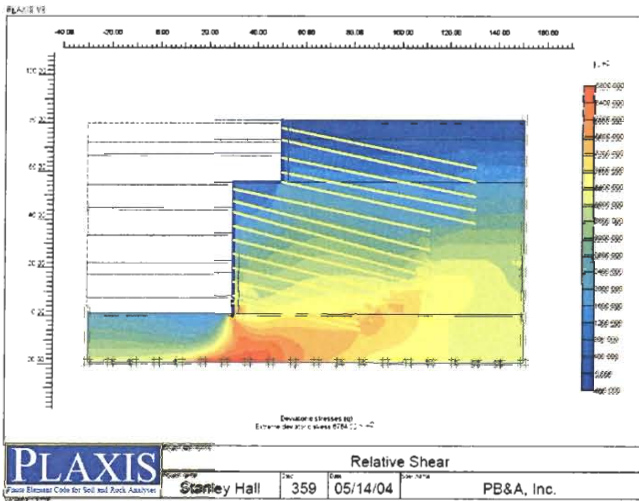
Fig. 13: Relative Shear Stress

Two dimensional Finite Element Analysis Program "Plaxis" has been used to corroborate the wall deformations and to calibrate the parameters used in the design. The objective was to choose soil parameters and moduli for different strata so that the deformations of the wall would duplicate the actual field measurements. Further, by method of $\phi - C$

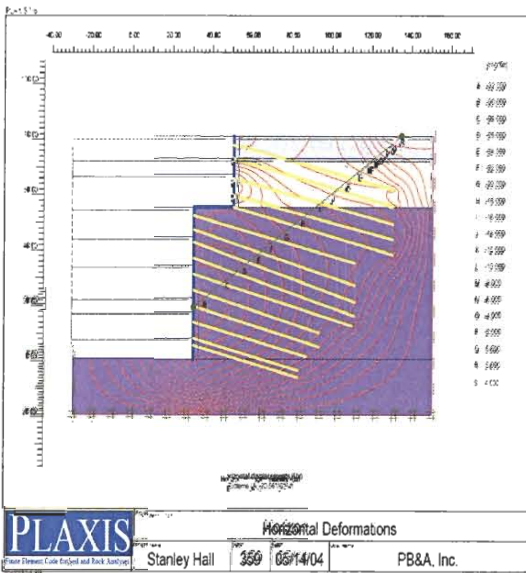
Fig. 14: Horizontal Deformation Contours
